**TARGETED BROWNFIELDS ASSESSMENT
ASBESTOS CONTAINING BUILDING MATERIALS AND
LEAD-BASED PAINT INSPECTIONS**

**Fort Wolters Texas Department of Criminal Justice Property
16.37 Acre Tract at the Southeast Corner of Cross Post Rd. and Grant Rd.
Mineral Wells (Parker County), Texas 76067**

Report Date: October 21, 2010

dse Project N^o : 1037503

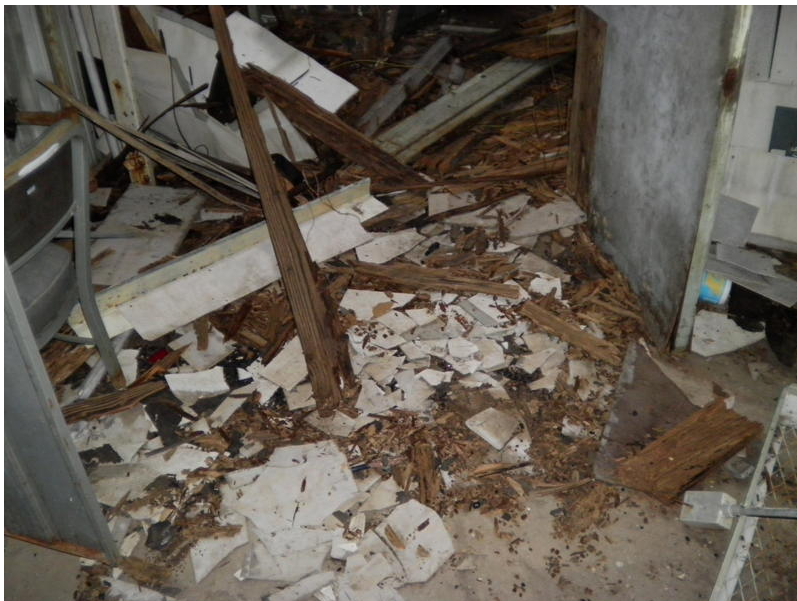
PHOTO 5 ►

Transite debris identified as ACBM in interior of Building 540.

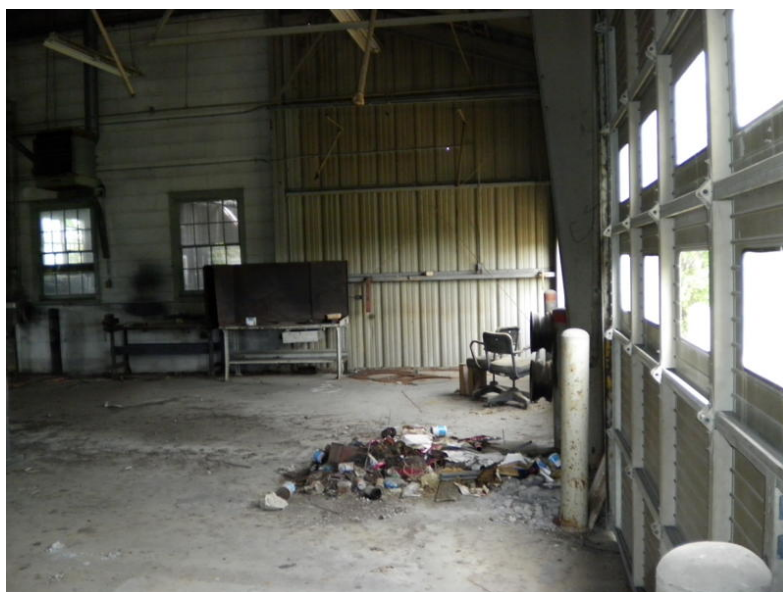
PHOTO 6 ►

TSI debris observed in Building 540; sampling at other locations indicated this debris included ACBMs.
